EVALUATING THE USE OF FAIRMOUNT DAM FISH PASSAGE FACILITY WITH APPLICATION TO ANADROMOUS FISH RESTORATION IN THE SCHUYLKILL RIVER, PENNSYLVANIA

Lance H. Butler

Office of Watersheds, Philadelphia Water Department

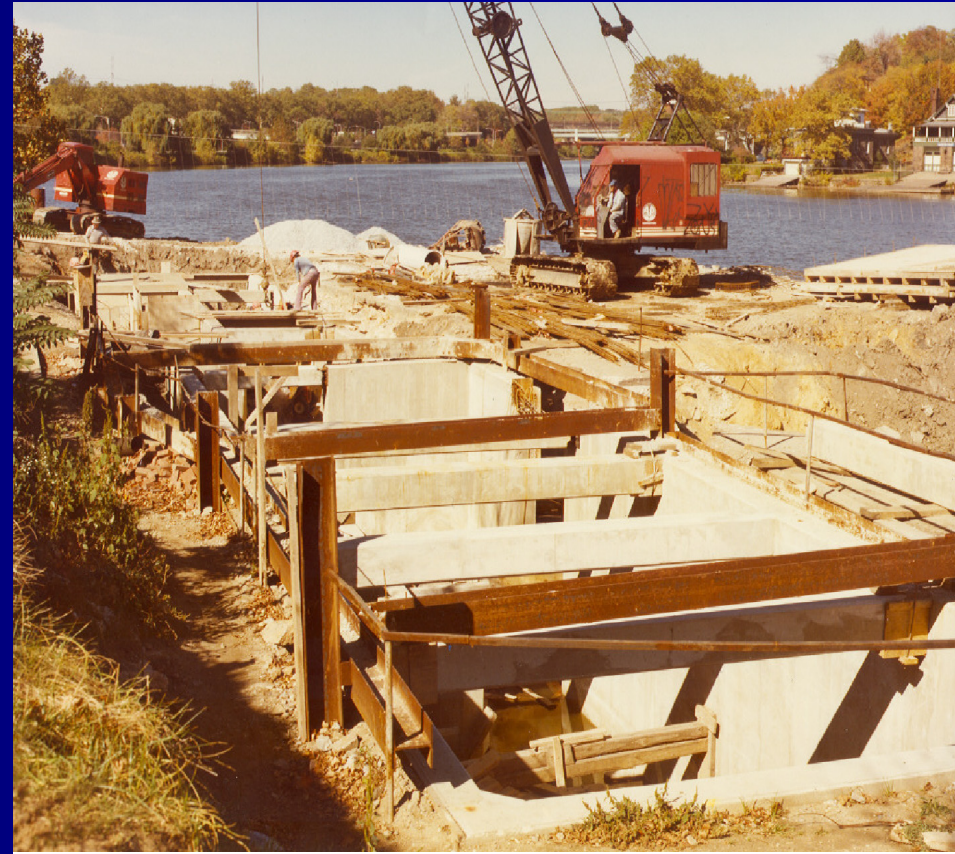
Construction Of Fairmount Fish Ladder, 1978

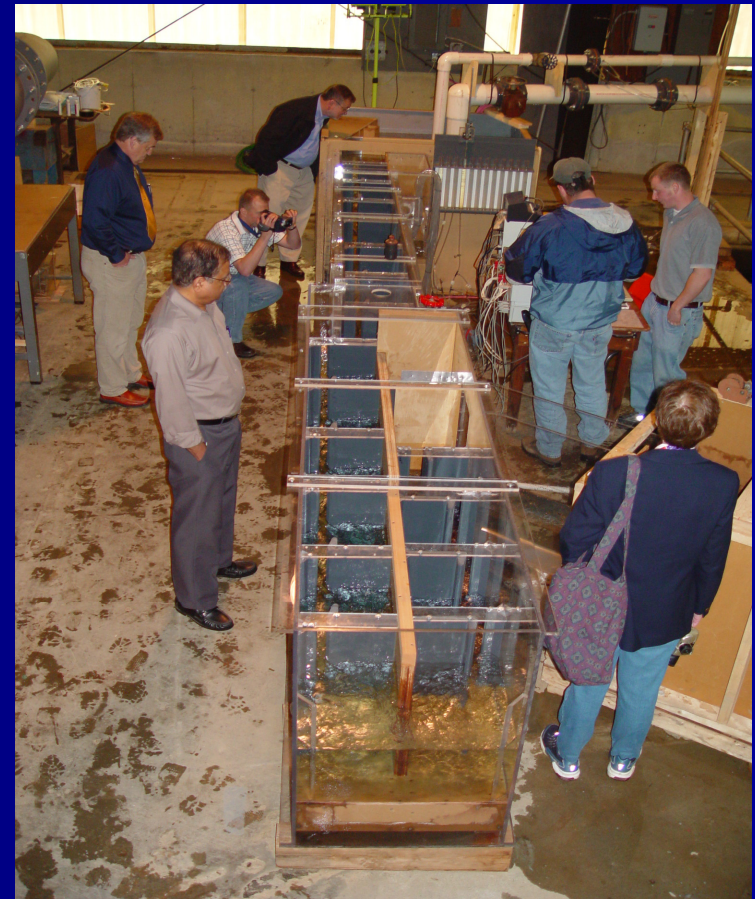
9:1 scale of the Fairmount Fish Ladder (Alden Laboratories, Worcester, MA)

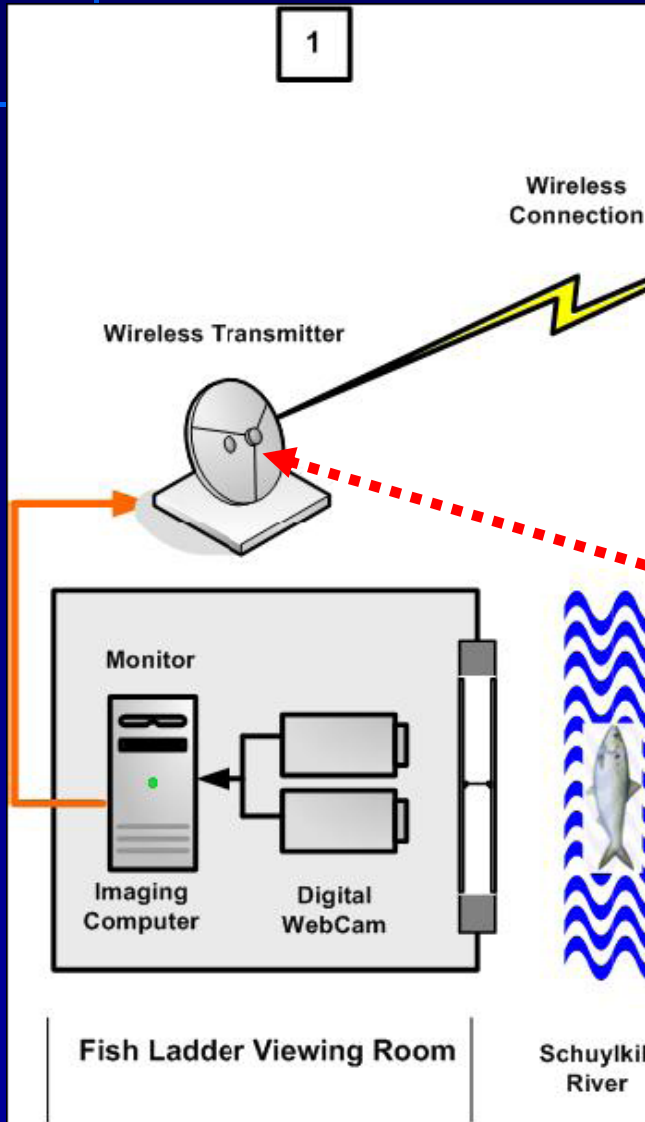
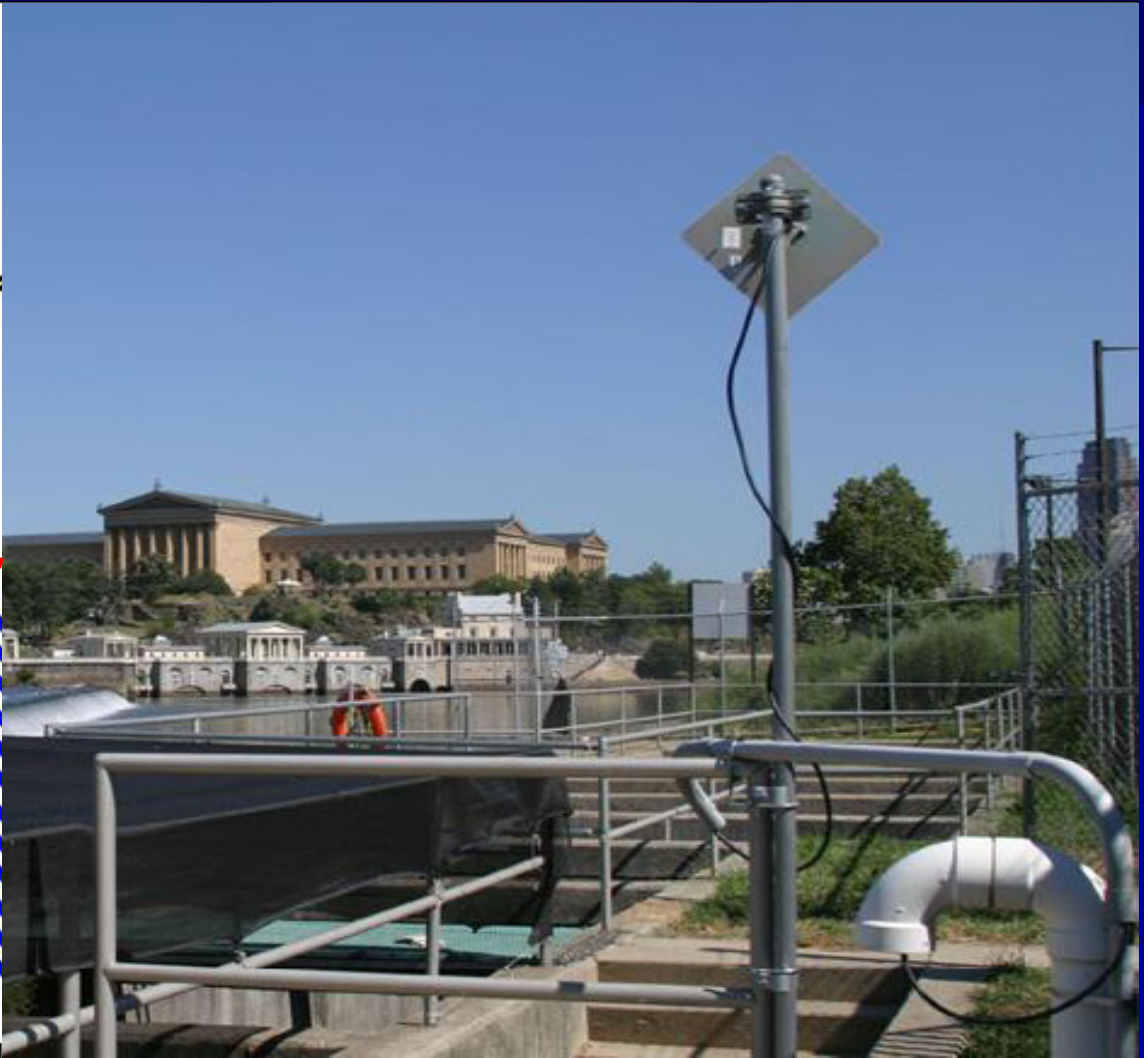
Wireless Transmitter

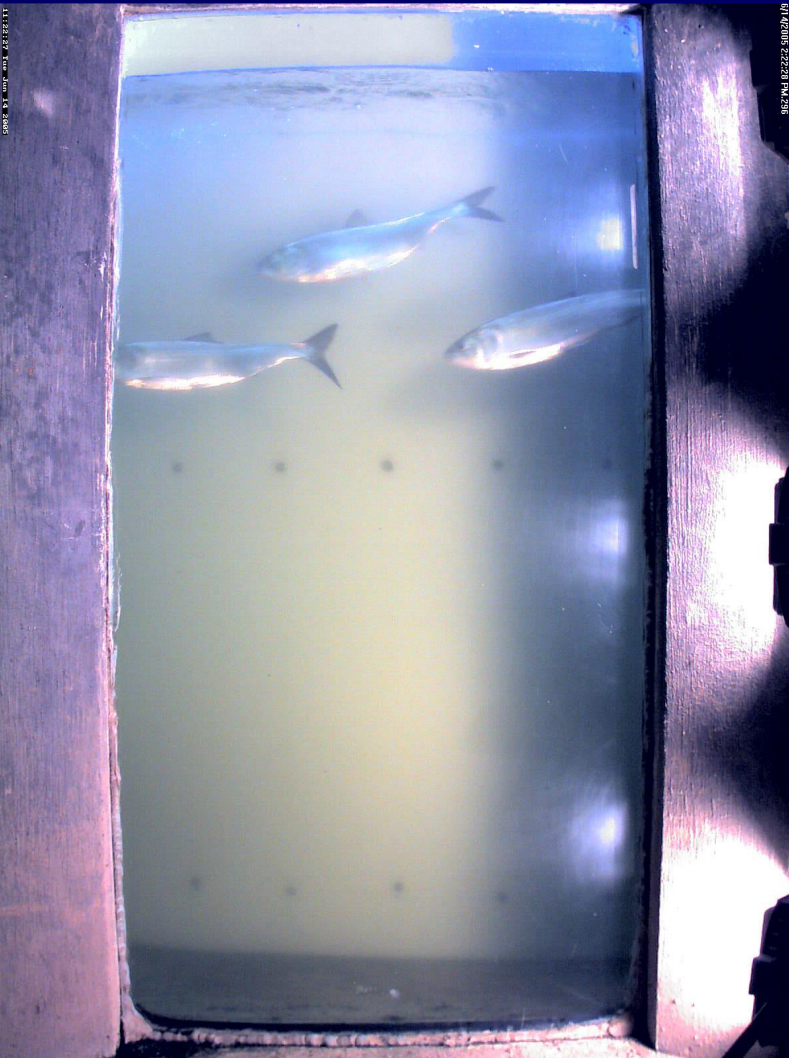
Video Transmission

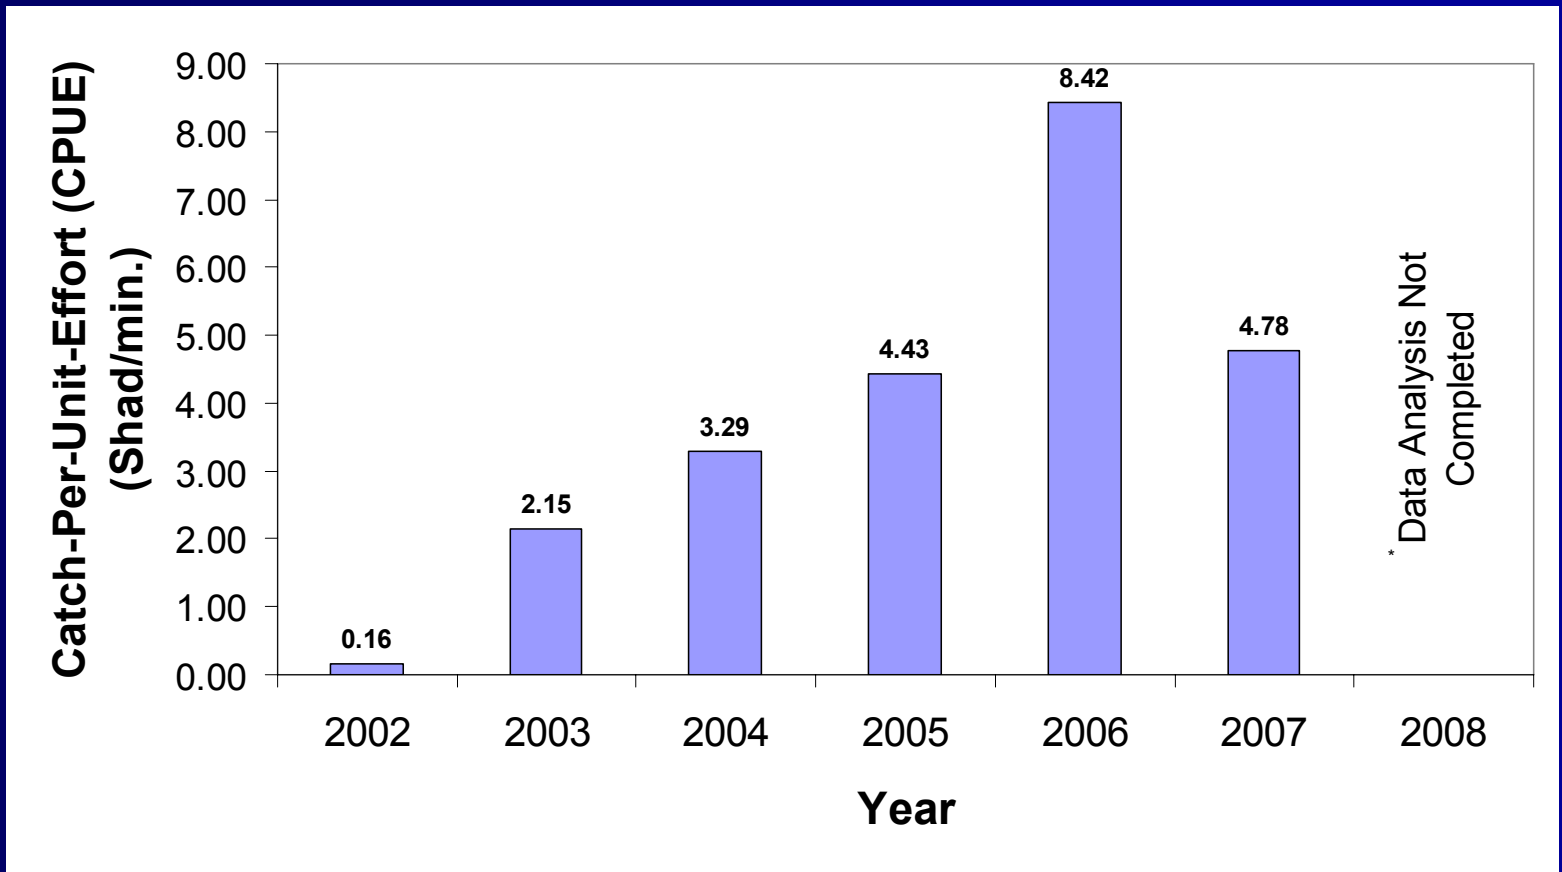
Tidal Schuylkill River Fish Survey Results

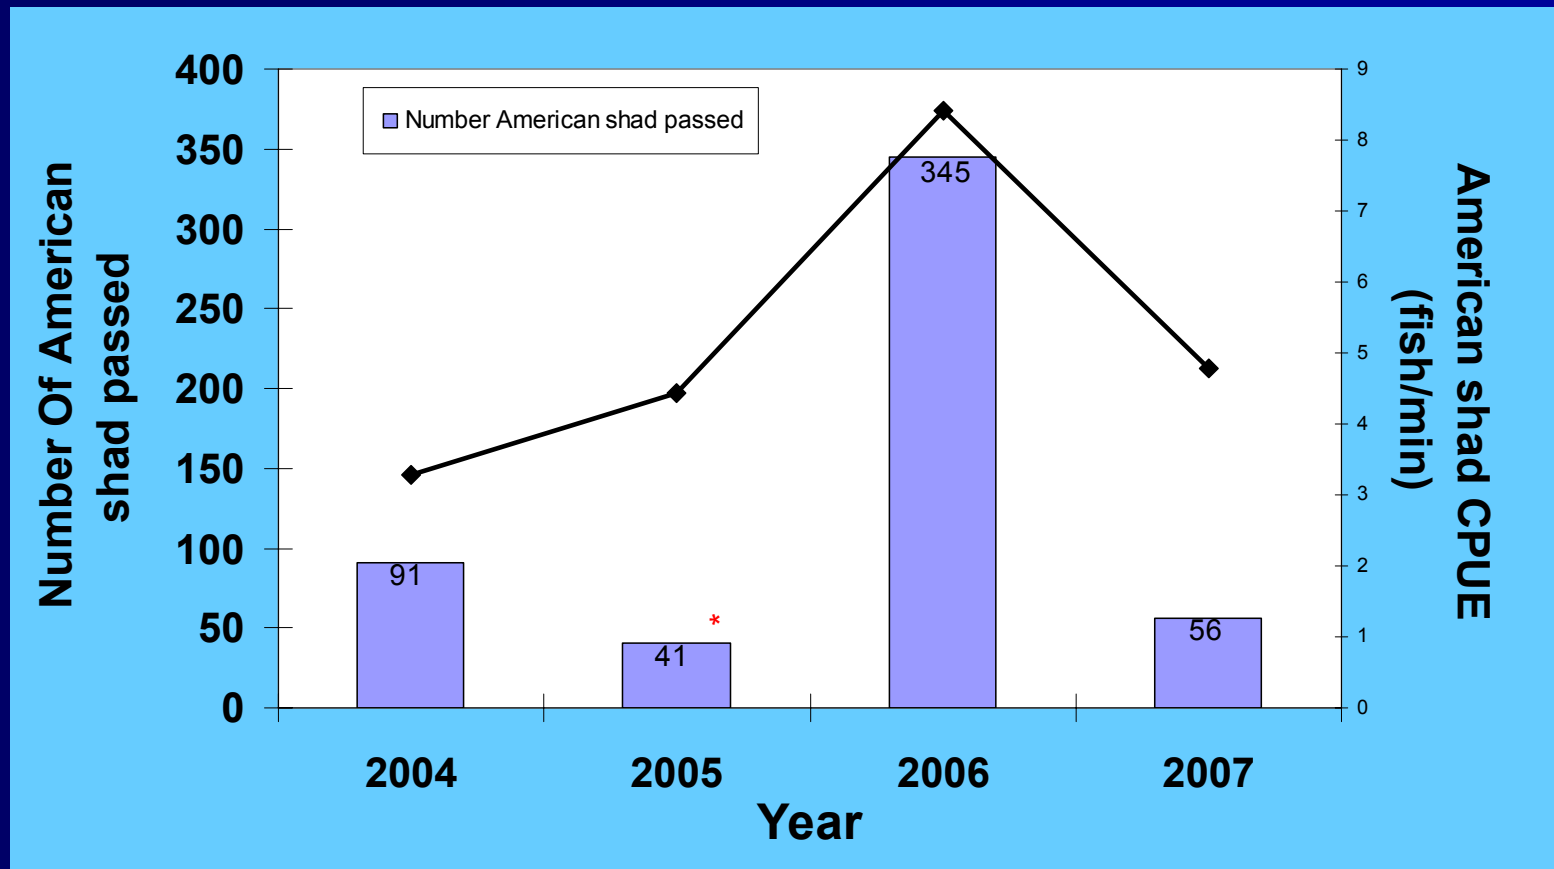
Video Surveillance Results

* Power outage

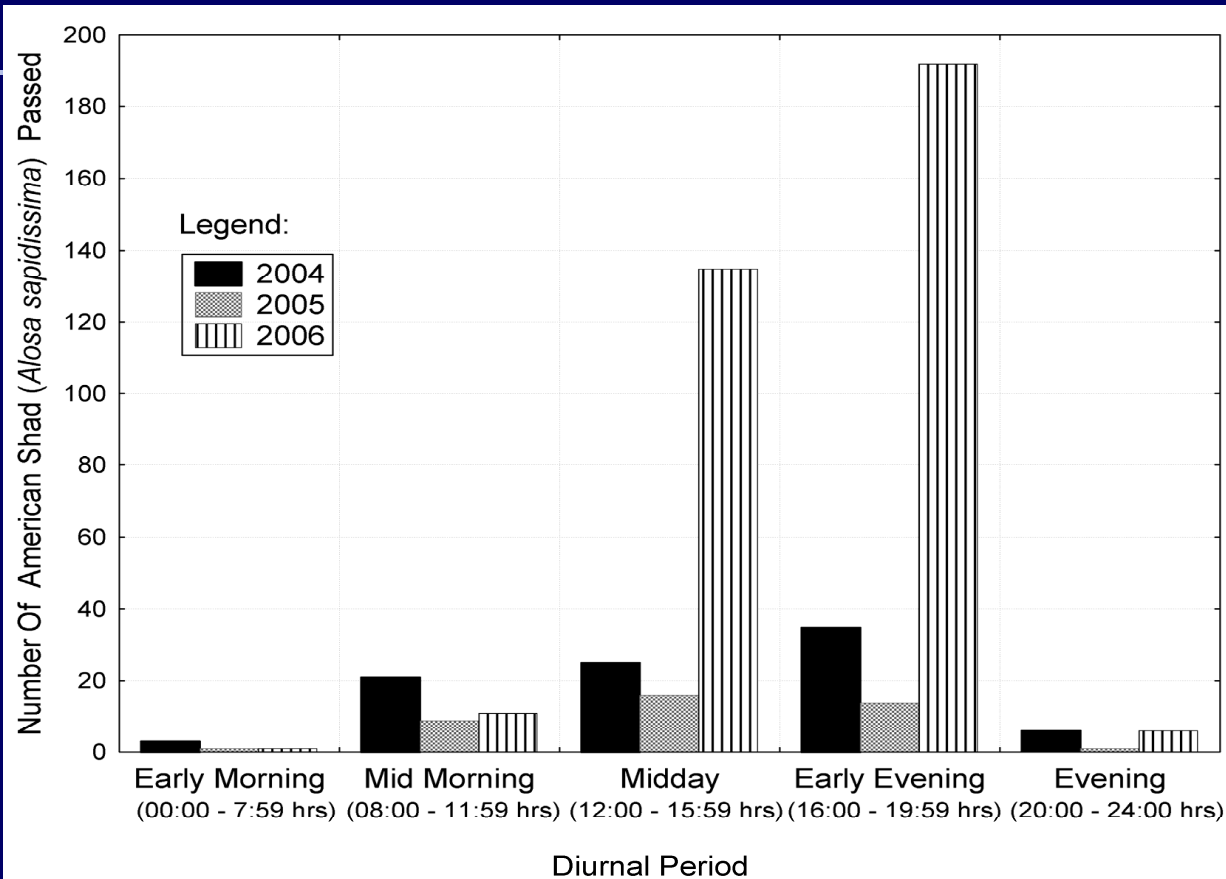
Temporal Variability In Fish Passage

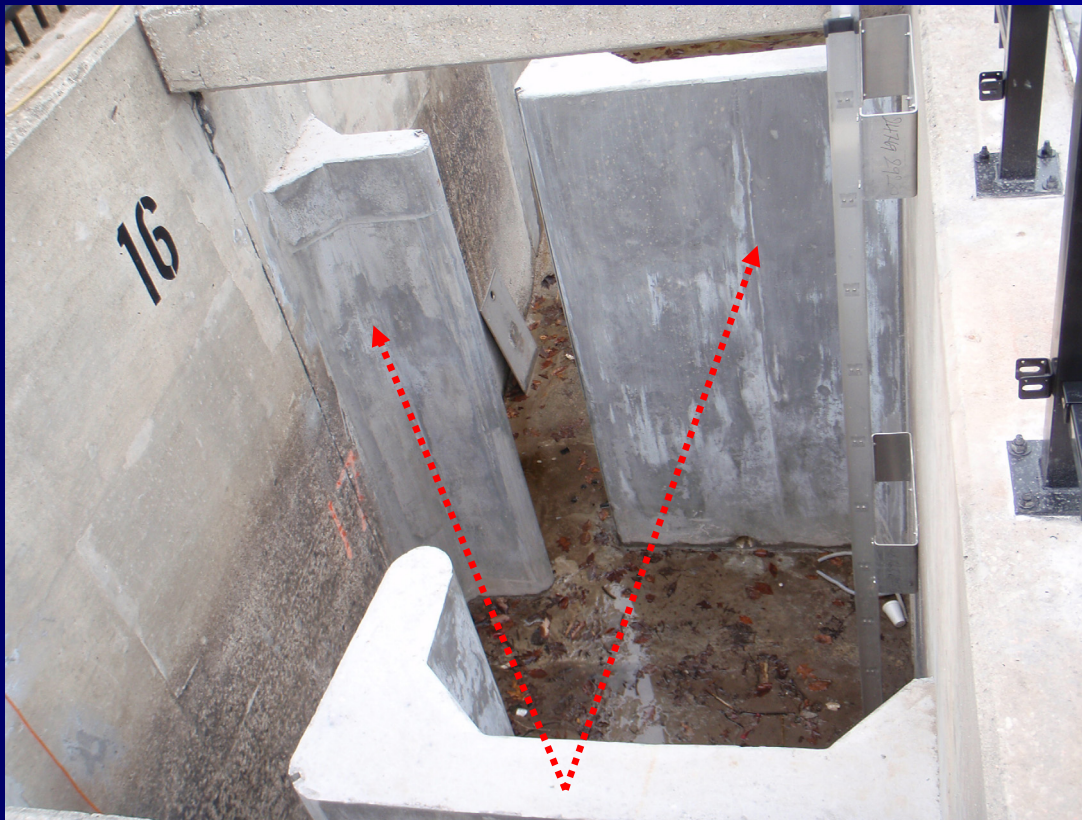
New chambers

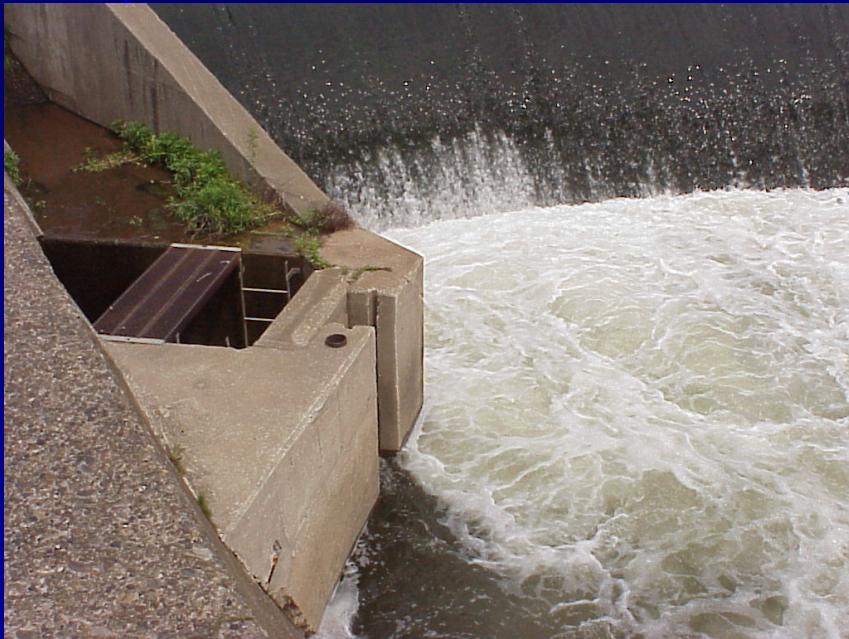
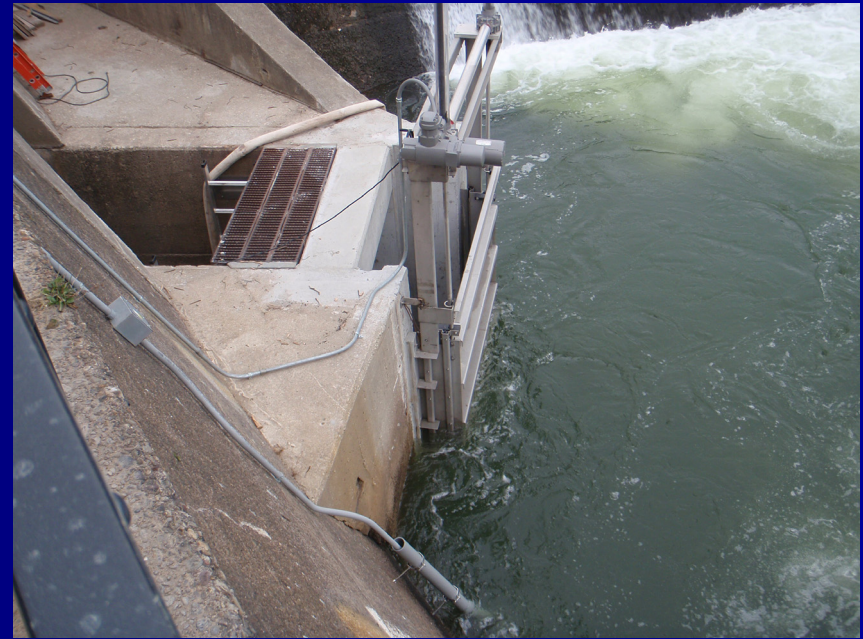
New entrance channel with automated gate system

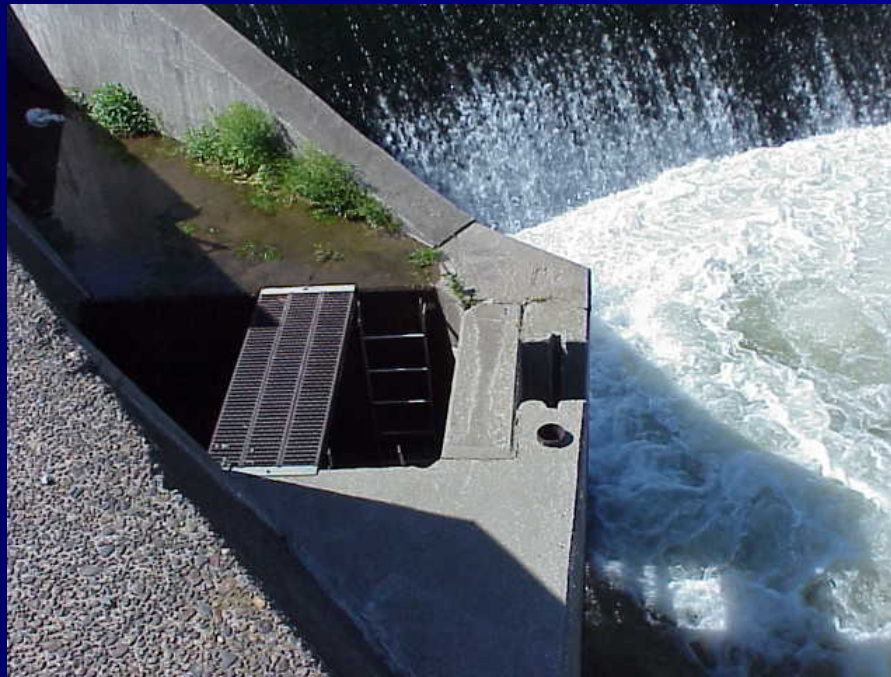
New "Non-Overflow" section of fish ladder

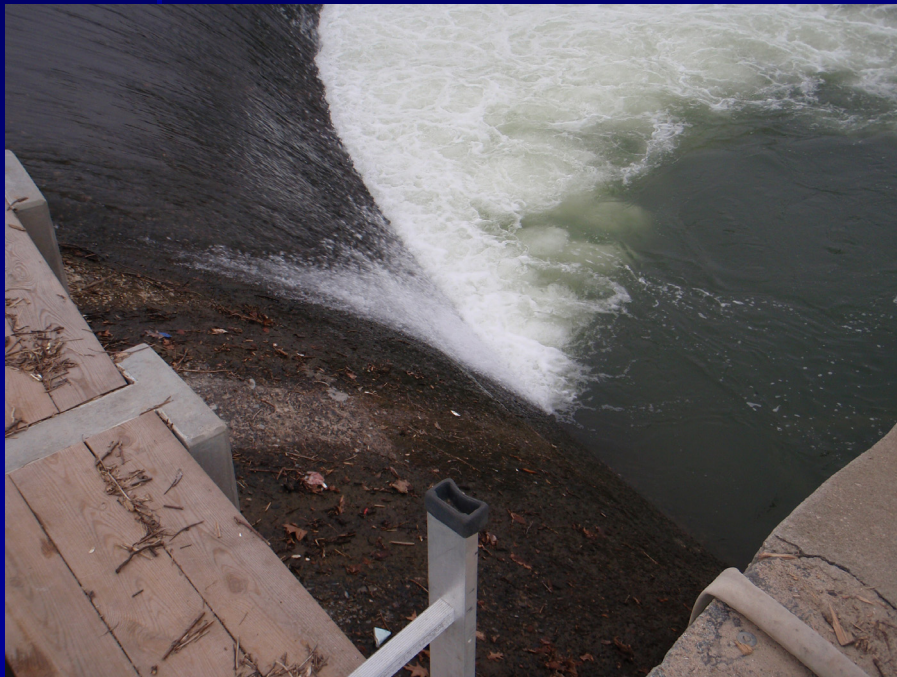
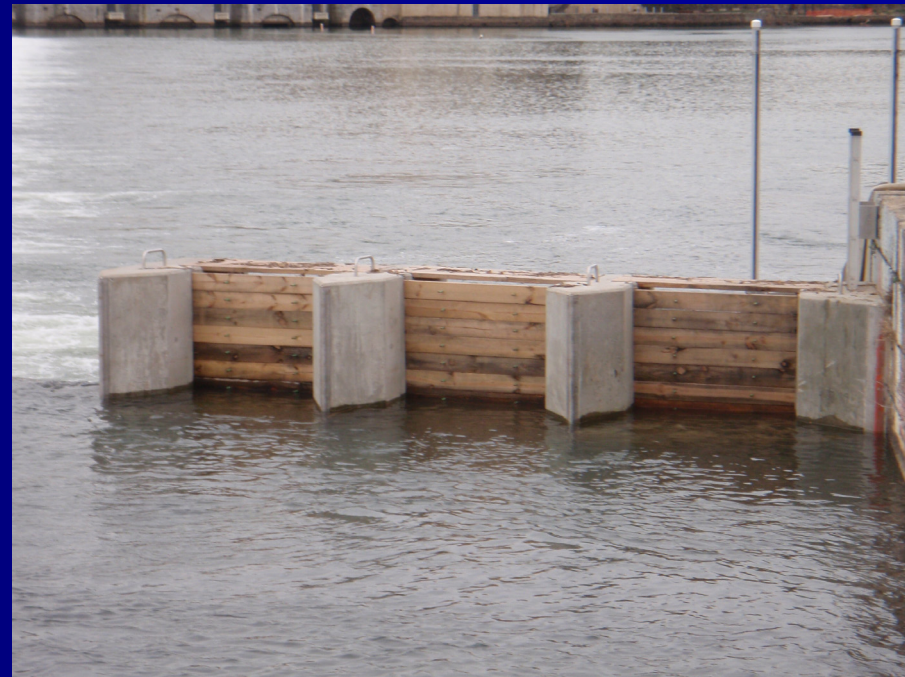
New "Non-Overflow" section of fish ladder

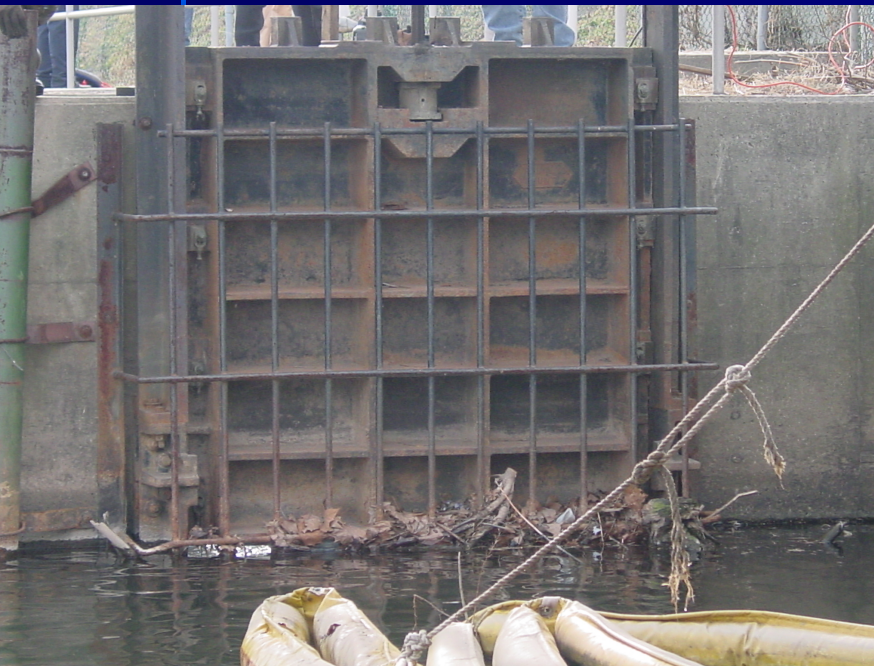
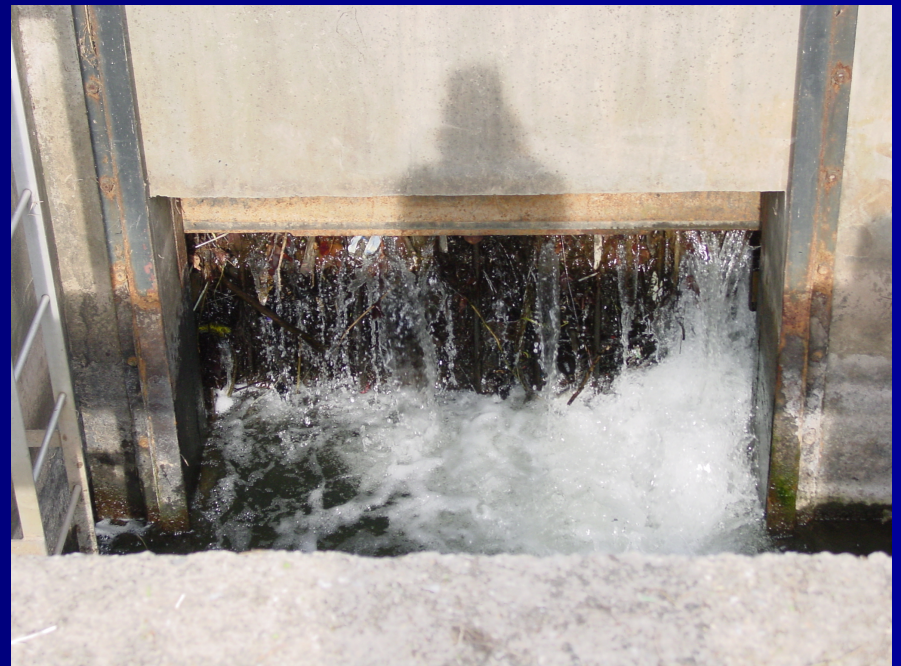
New exit channel with attraction flow system and debris deflection system

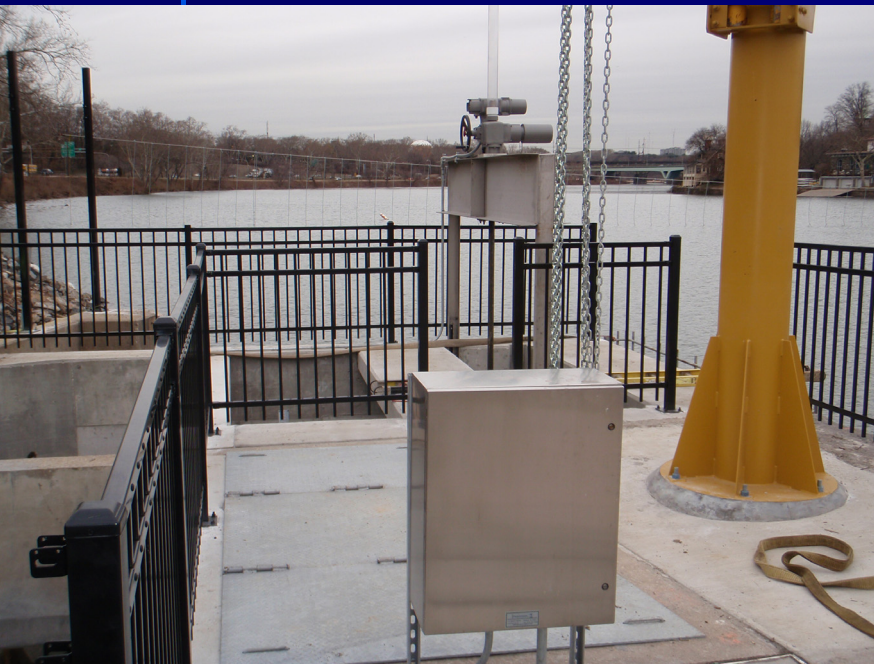
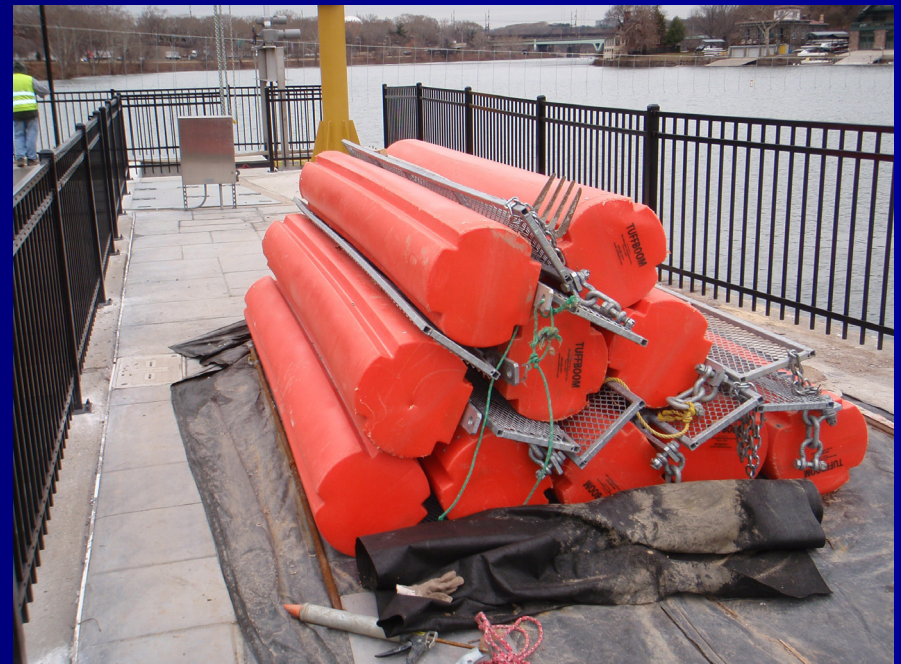
New exit channel with attraction flow system and debris deflection system
