REPORT ON
**FLOOD CONTROL
FRANKFORD CREEK**

**CITY OF PHILADELPHIA
PENNSYLVANIA**

**KNAPPEN ENGINEERING COMPANY
NEW YORK 10, N. Y.
OCTOBER 1947**

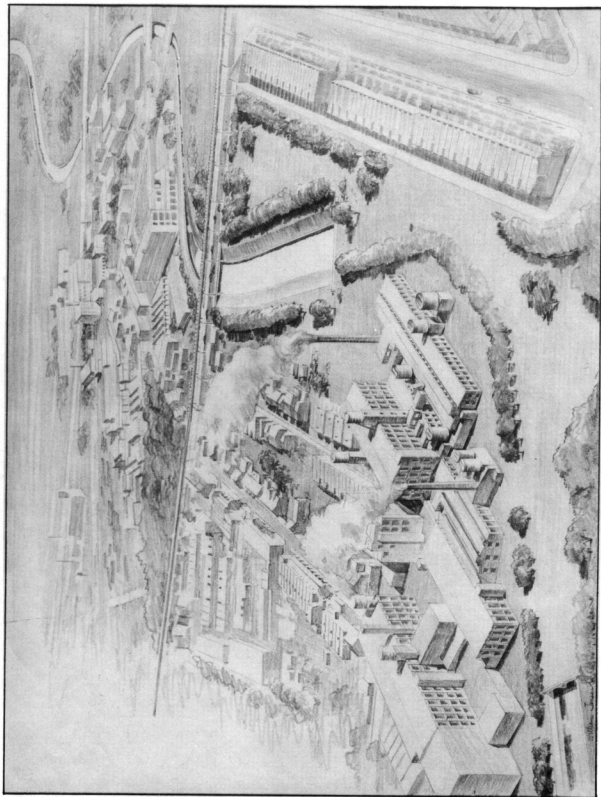
PROPOSED FRANKFORD CREEK IMPROVEMENT
CONDUIT SECTION IN FOREGROUND
CITY OF PHILADELPHIA

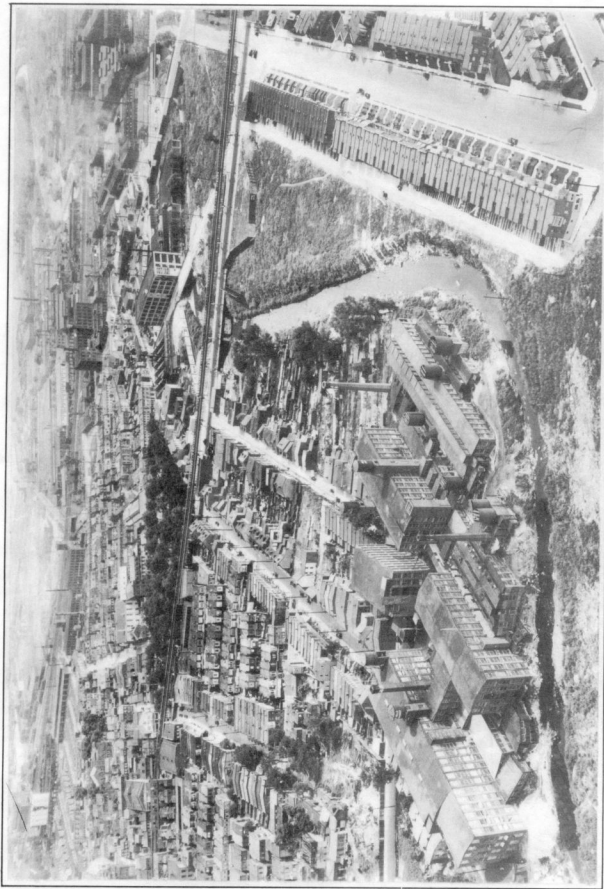
EXISTING CONDITIONS ALONG FRANKFORD CREEK, LOOKING SOUTHEAST FROM LEIPER STREET

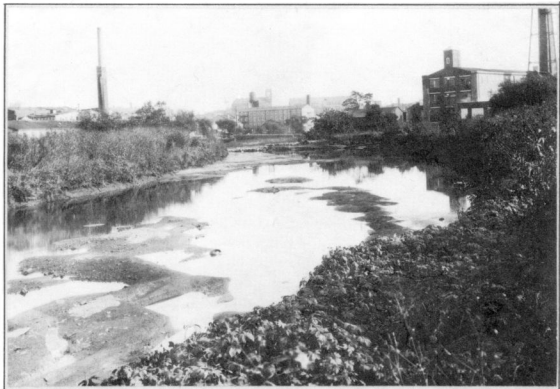
A - VIEW TAKEN NOVEMBER 10, 1932, SHOWING MILL POND FILLED WITH SEDIMENT

SITE OF OLD DAM ABOVE WINGOHOCKING STREET

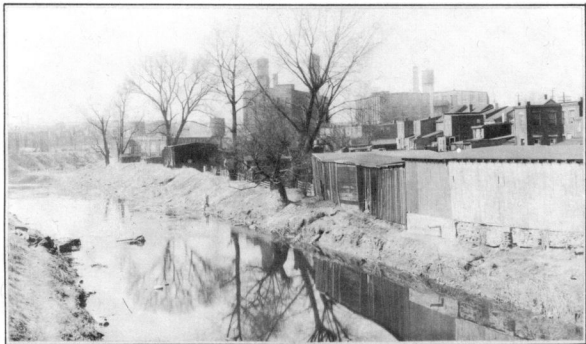
A - LOOKING UPSTREAM FROM KENSINGTON AVENUE. INADEQUATE LEVEE ALONG BANK AT RIGHT.

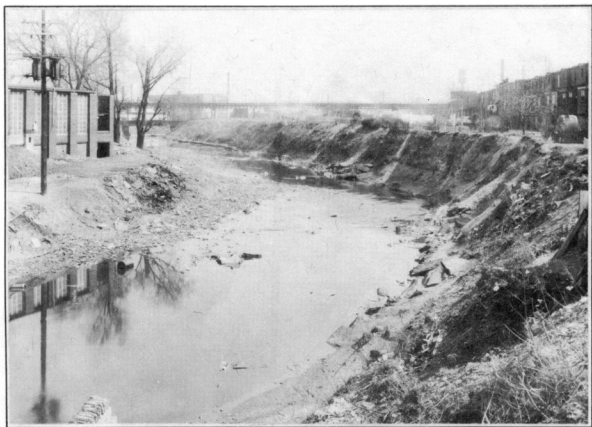
B - LOOKING DOWNSTREAM FROM LEIPER STREET TOWARDS KENSINGTON AVENUE. PROTECTION OF BANKS AT RIGHT REQUIRES HIGH WALLS OR A SECTION OF COVERED CONDUIT.

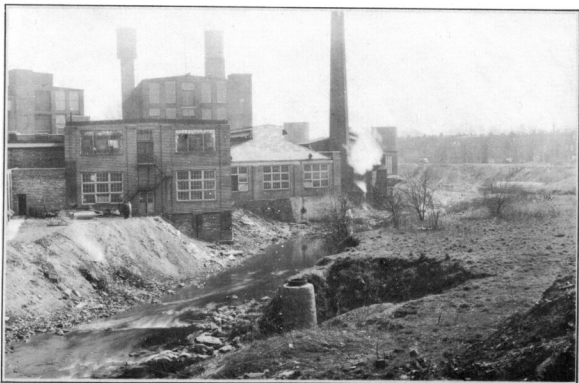
A—LOOKING DOWNSTREAM FROM BRISTOL STREET EXTENDED. ENCROACHMENTS ON LEFT BANK HAVE FORCED CREEK TO ERODE RIGHT BANK.

or timber and concrete bulkheads (See Plate 11). Except for one or two short sections of timber cribbing, there is no protection in the 7,200-foot reach between Margaret Street and the Pennsylvania Railroad (See Plate 9). Between the Pennsylvania Railroad and Kensington Avenue, the construction of buildings has required almost a continuous line of concrete or masonry walls. Above Kensington Avenue the banks are unprotected (See Plate 4) except where foundation walls are required for the large mill in the vicinity of Leiper Street (See Plate 5A).

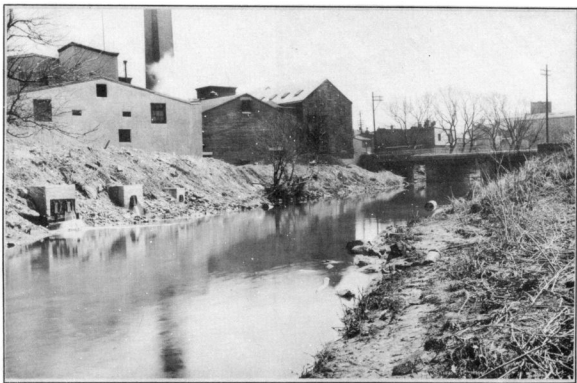
B—LOOKING DOWNSTREAM AT WINGOHOCKING STREET BRIDGE. POOR ALIGNMENT AND INADEQUATE WATERWAY REQUIRE RECONSTRUCTION OF THIS BRIDGE.

In their present condition, nine of the fourteen bridges seriously restrict the passage of flood flows, either because of narrow openings, poor alignment or deposition of sediments under the bridges (See Plates 5B, 7, 8A, 9A, and 11A). The most serious constriction is at Bridge Street where the opening is very narrow and further contracted by protective pile structures (See Plate 11A). This bridge is reported to be in an unsatisfactory structural condition and would normally be replaced in a short time. As will be pointed out later in this report, complete reconstruction is considered necessary for only five of the fourteen bridges and two of the five are relatively unimportant pile structures. One footbridge (Plate 6B) is now abandoned, so its removal will be relatively simple.

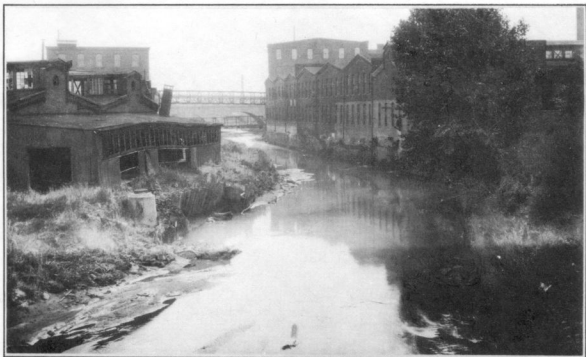
A - VIEW TAKEN ON OCTOBER 13, 1932

CHANGES IN ENCROACHMENT CONDITIONS BELOW FRANKFORD AVENUE.

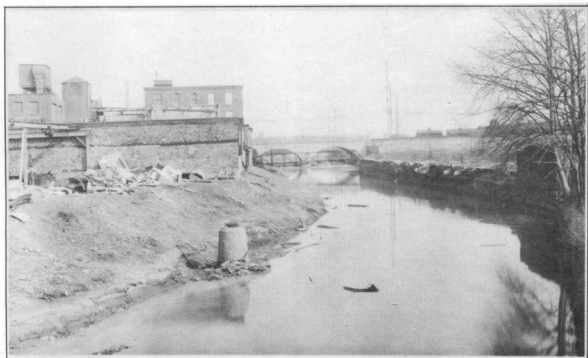
B - SAME REACH AS SHOWN ABOVE ON APRIL 8, 1947. ARCH BRIDGE IS CROSSING OF THE PENNSYLVANIA RAILROAD. STEEL TRUSS FOOTBRIDGE HAS BEEN ABANDONED.

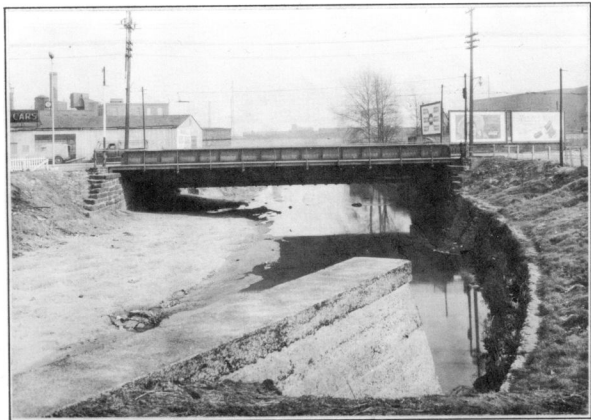
**A- LOOKING DOWNSTREAM AT FRANKFORD AVENUE BRIDGE. SEDIMENT DEPOSITS
RESTRICT WATERWAY OPENING**

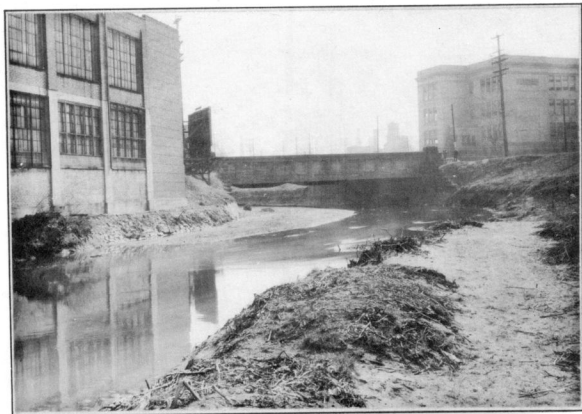
**B- LOOKING DOWNSTREAM AT TORRESDALE AVENUE BRIDGE. LOWER SECTION OF WIN-
DOWS AT LEFT FILLED IN TO PREVENT FLOOD DAMAGE.**

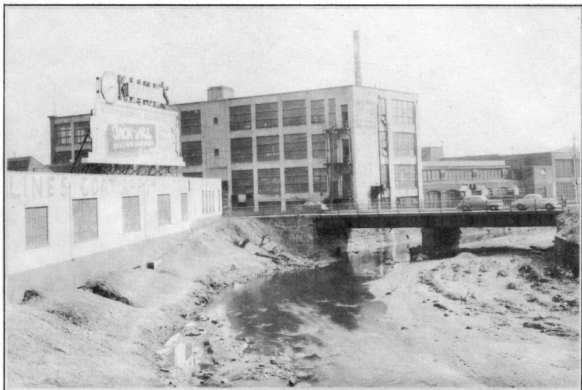
A—LOOKING DOWNSTREAM AT WORRELL STREET BRIDGE. PROPOSED IMPROVEMENTS WILL REQUIRE REMOVAL OR REPLACEMENT OF THIS BRIDGE.

All the existing bridges except that at Worrell Street would be incorporated in the new channel. Removal of the Worrell Street bridge is recommended.

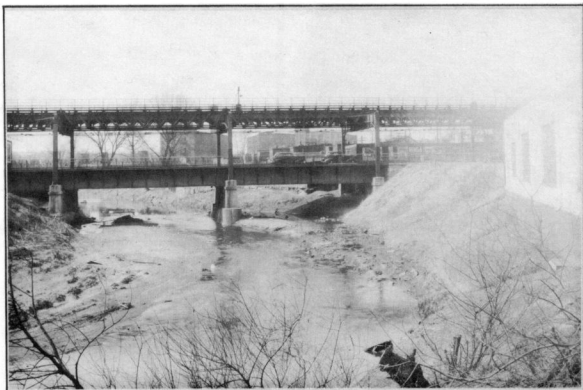
B—LOOKING UPSTREAM AT KENSINGTON AVENUE BRIDGE. CENTER LINE OF PROPOSED CHANNEL IS LOCATED IN LEFT HAND OPENING.

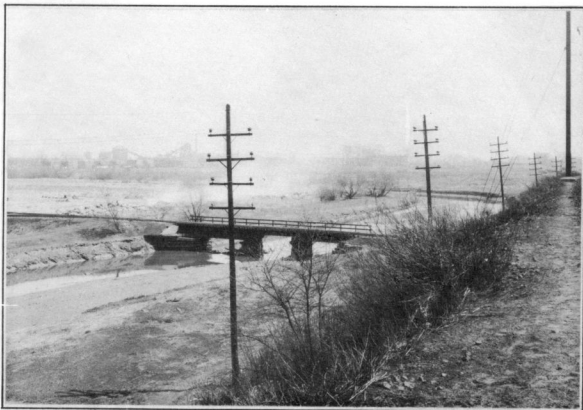
A- LOOKING DOWNSTREAM FROM ARAMINGO AVENUE. UPSTREAM END OF RECOMMENDED CUT-OFF CHANNEL TO DELAWARE RIVER WOULD BEGIN AT RIGHT OF PICTURE.

**VIEWS OF UNDEVELOPED AREA BETWEEN
ORTHODOX STREET AND PENNSYLVANIA RAILROAD**

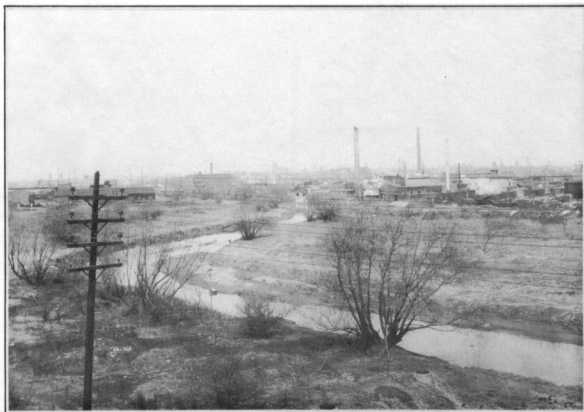
B - LOOKING UPSTREAM FROM ARAMINGO AVENUE. AN EARTH CHANNEL IS SUITABLE FOR THIS REACH

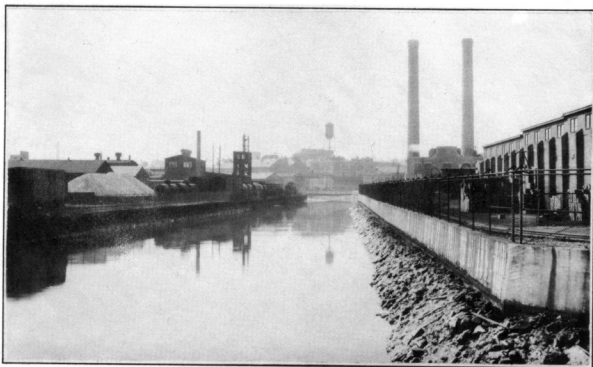
A-LOOKING UPSTREAM FROM MOUTH OF CREEK. ARSENAL WALL ON RIGHT. PRIVATELY-OWNED BULKHEAD ON LEFT.

FRANKFORD CREEK BETWEEN DELAWARE RIVER AND BRIDGE STREET

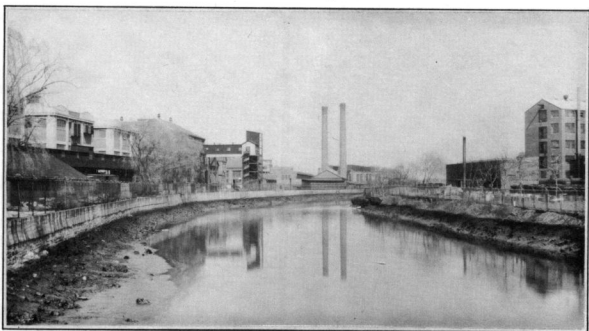
B-LOOKING DOWNSTREAM FROM BRIDGE STREET. ARSENAL WALL ON LEFT.

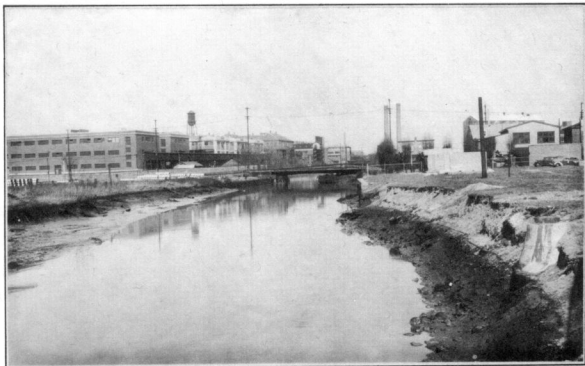
A—LOOKING DOWNSTREAM AT BRIDGE STREET SHOWING SMALL WATERWAY OPENING.

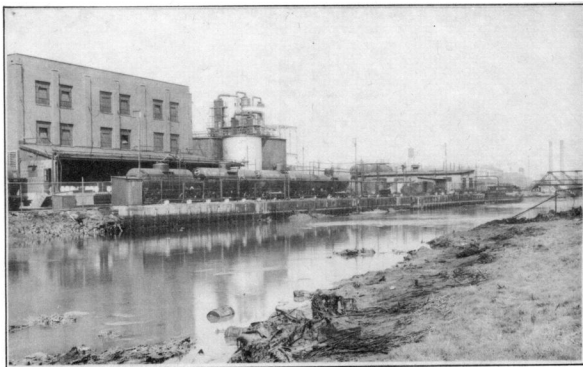
B— PRIVATELY OWNED BULKHEAD LOCATED ON NORTH BANK BETWEEN BRIDGE STREET AND MARGARET STREET. THIS BULKHEAD CAN BE INCORPORATED IN THE IMPROVED CHANNEL.

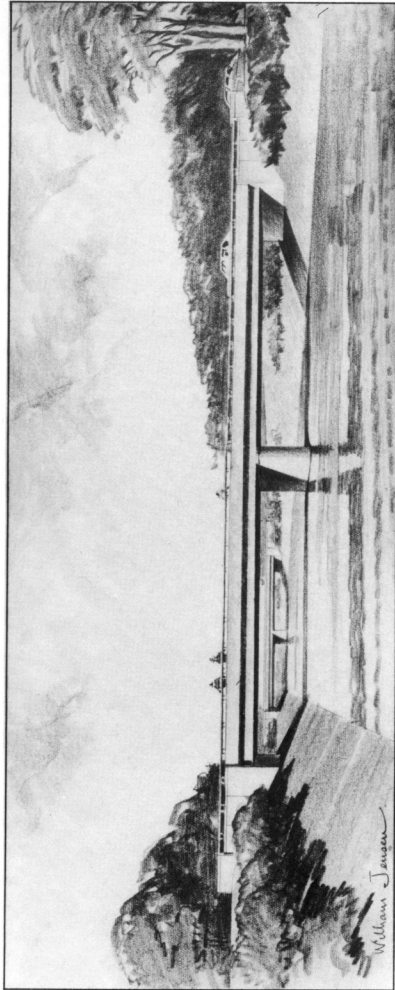
PROPOSED CUT-OFF CHANNEL & RICHMOND STREET BRIDGE
FRANKFORD CREEK FLOOD CONTROL PROJECT
CITY OF PHILADELPHIA

With the Recommended Scheme the present bridges at Orthodox Street and Margaret Street could be abandoned, while the Bridge Street bridge could eventually be replaced by a relatively small culvert. The railroad bridge below Aramingo Avenue would be enlarged by the addition of two spans and two abutments. The railroad bridge at Amber Street extended would be lengthened. Four bridges would be required over the cut-off proper as follows: Thompson Street, Richmond Street, Belt Line Railroad and Kensington & Tacony Railroad. For sketches of the proposed highway bridges see Drawing No. R136-20 and Plate No. 12.

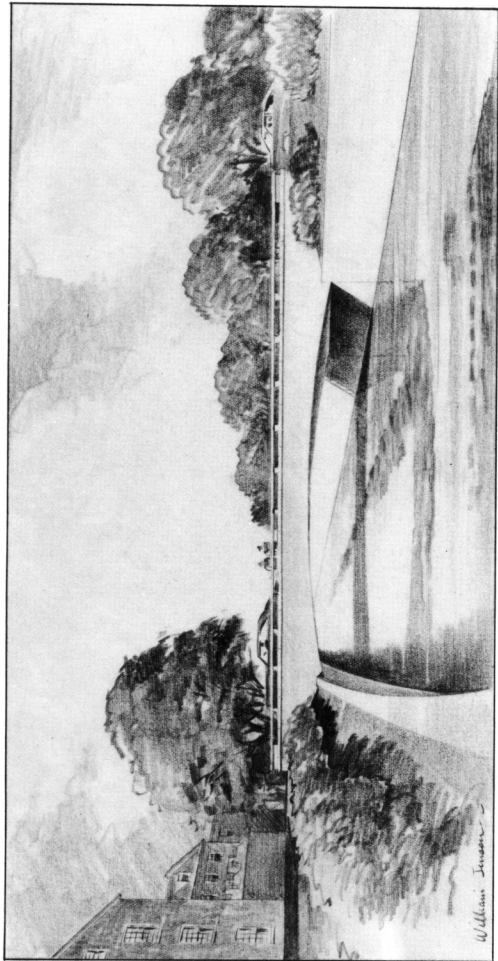
PROPOSED CHANNEL & WINGHOCKING STREET BRIDGE
FRANKFORD CREEK FLOOD CONTROL PROJECT
CITY OF PHILADELPHIA

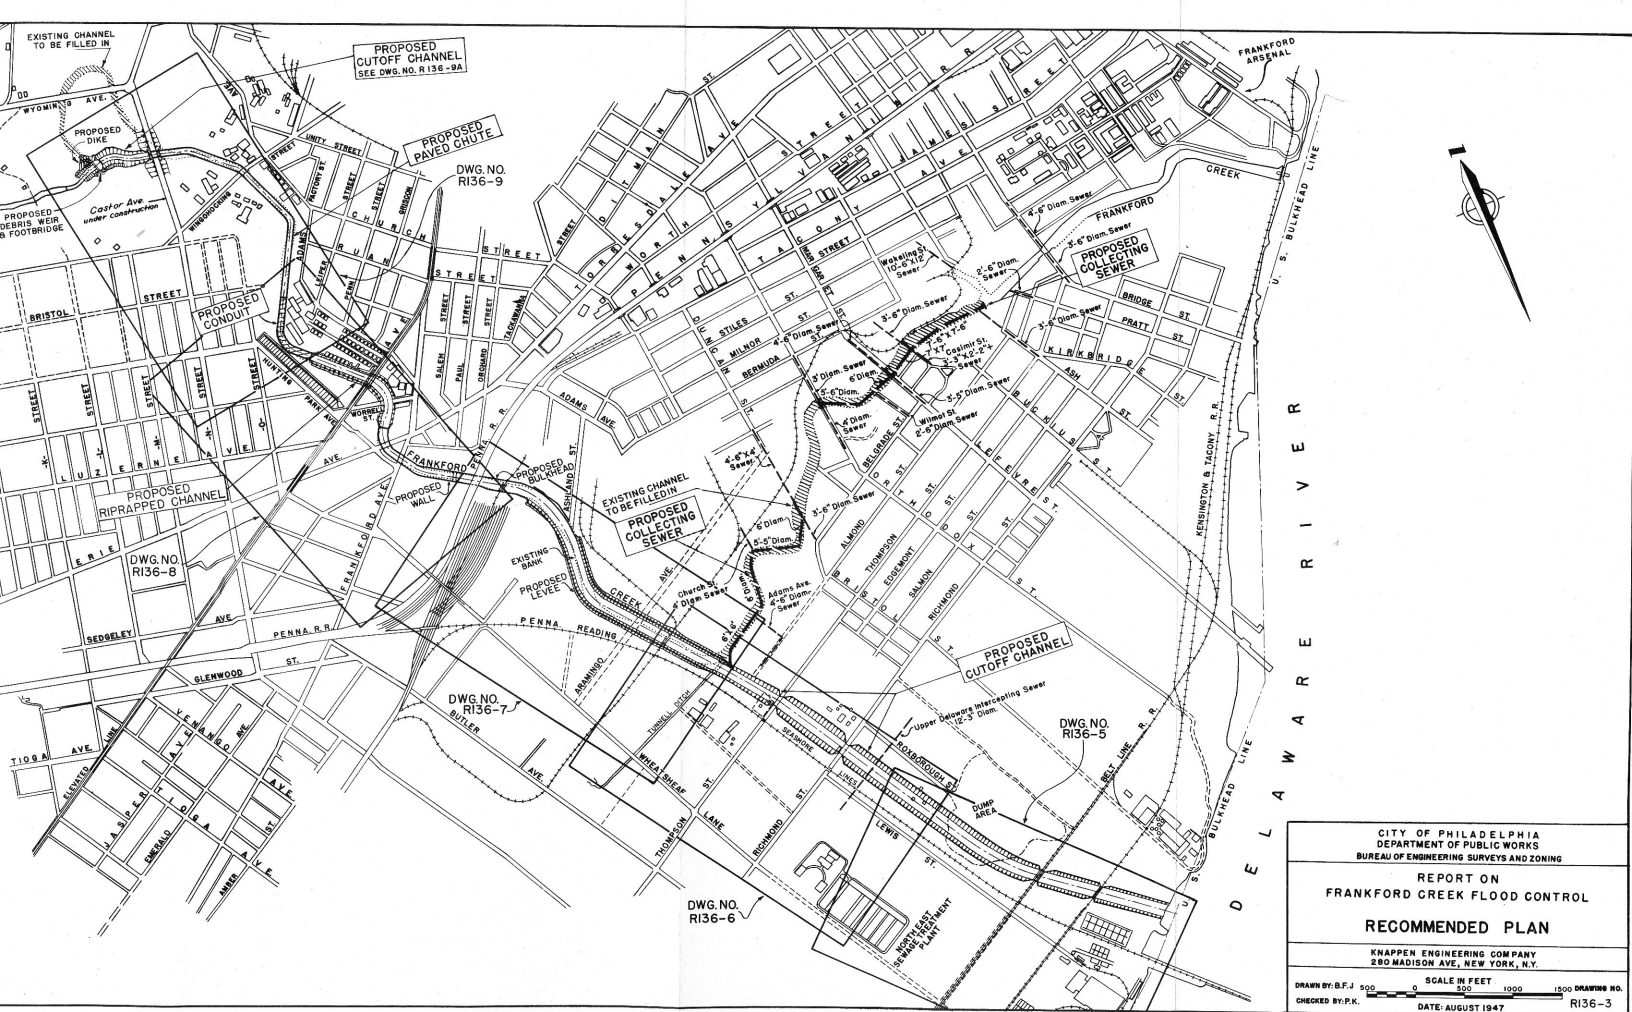
R136-3

PROPOSED CUTOFF CHANNEL
SEE DWG. NO. R136-8A

PROPOSED PAYED CHUTE
DWG. NO. R136-9

RECOMMENDED PLAN

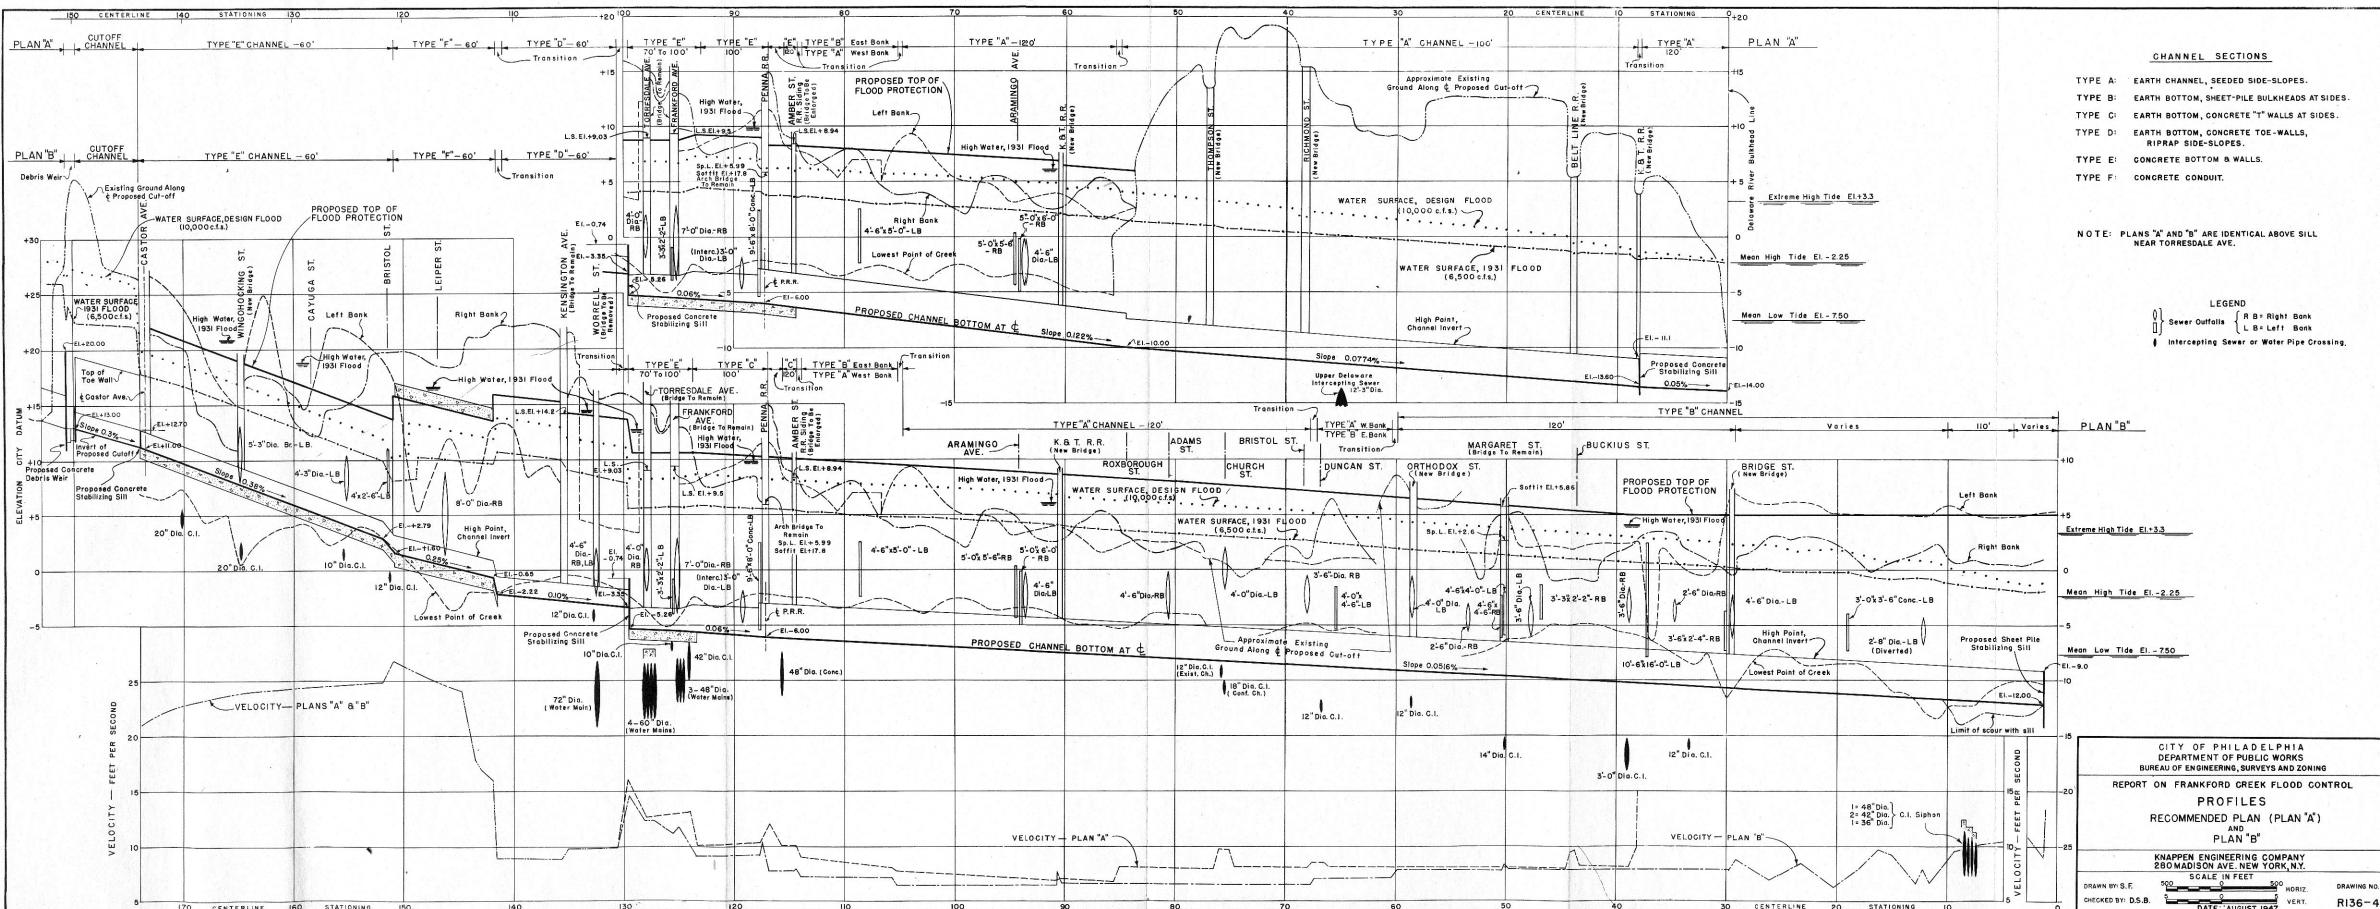
CHANNEL SECTIONS

- TYPE A: EARTH CHANNEL, SEEDED SIDE-SLOPES.
- TYPE B: EARTH BOTTOM, SHEET-PILE BULKHEADS AT SIDES.
- TYPE C: EARTH BOTTOM, CONCRETE "T" WALLS AT SIDES.
- TYPE D: EARTH BOTTOM, CONCRETE TOE-WALLS, RIPRAP SIDE-SLOPES.
- TYPE E: CONCRETE BOTTOM & WALLS.
- TYPE F: CONCRETE CONDUIT.

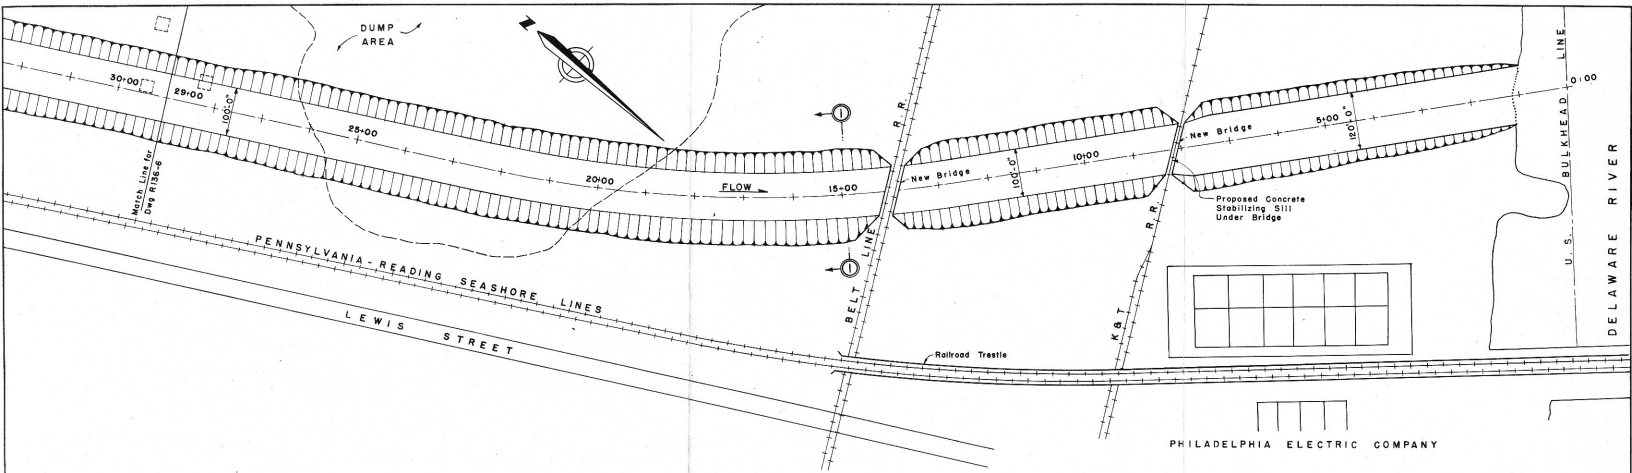
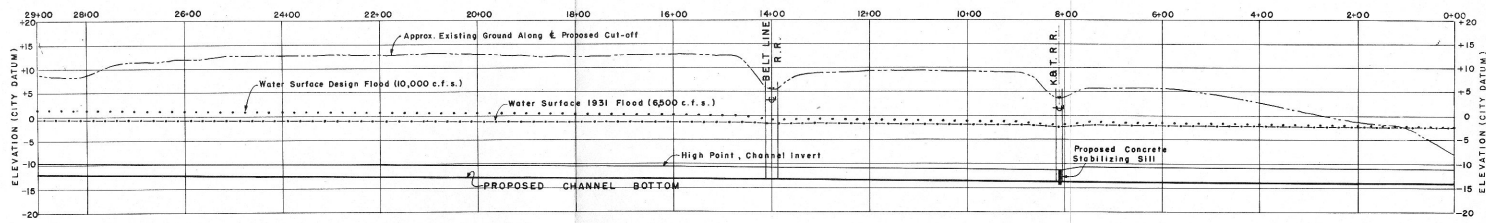
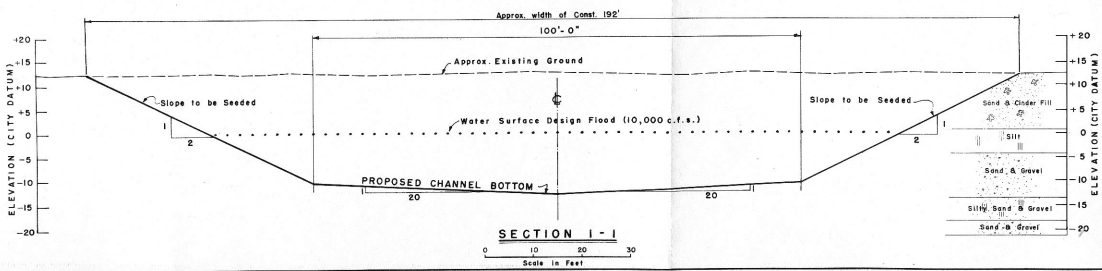
DRAWN BY: R. C. H. SCALE IN FEET 0 100 200 DRAWING NO. R136-5
 CHECKED BY: P. K. DATE: AUGUST 1947

CITY OF PHILADELPHIA
 DEPARTMENT OF PUBLIC WORKS
 BUREAU OF ENGINEERING SURVEYS AND ZONING
 REPORT ON FRANKFORD CREEK FLOOD CONTROL
 PLAN, PROFILE AND SECTIONS
 DELAWARE RIVER TO PENNA. R. R. BRIDGE
 RECOMMENDED PLAN SHEET 1 OF 3

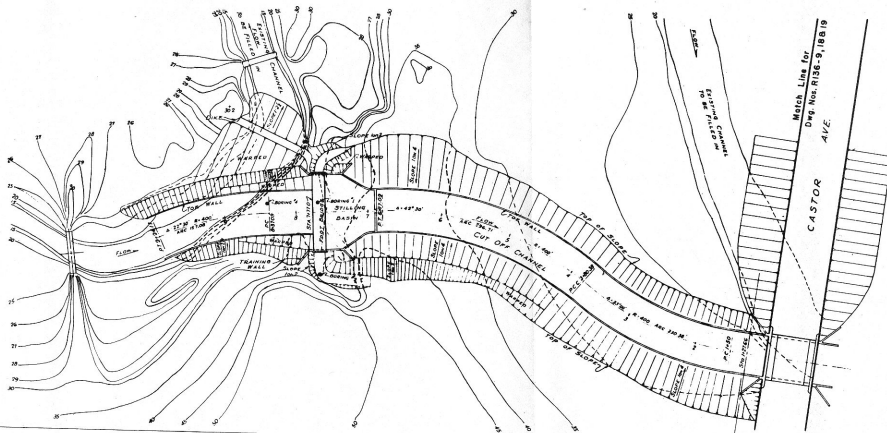
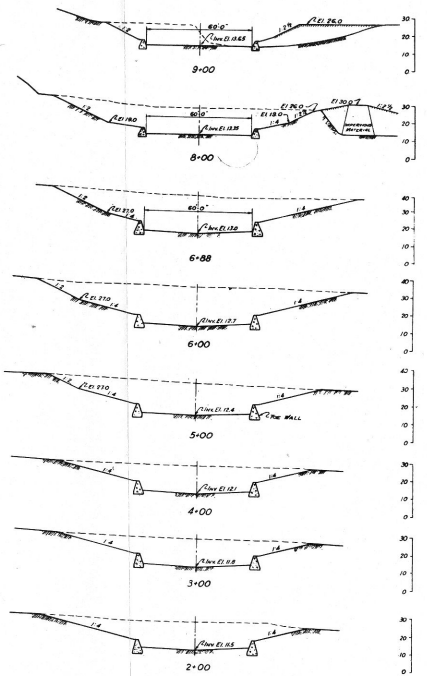
DRAWN BY: J.J.S. SCALE AS SHOWN DRAWING NO.
CHECKED BY: E.R. DATE: AUGUST 1947 R136-9A

BORINGS

BORING 1	BORING 2	BORING 3	BORING 4
1. SAND	1. SAND	1. SAND	1. SAND
2. SILT	2. SILT	2. SILT	2. SILT
3. CLAY	3. CLAY	3. CLAY	3. CLAY
4. GRAVEL	4. GRAVEL	4. GRAVEL	4. GRAVEL
5. ROCK	5. ROCK	5. ROCK	5. ROCK

PROFILE OF CUTOFF CHANNEL
SCALE IN FEET

SECTIONS OF CUTOFF CHANNEL
SCALE IN FEET

ALL SIDE SLOPES TO BE COVERED WITH 6" GRAVEL AND SEEDS AS SPECIFIED.

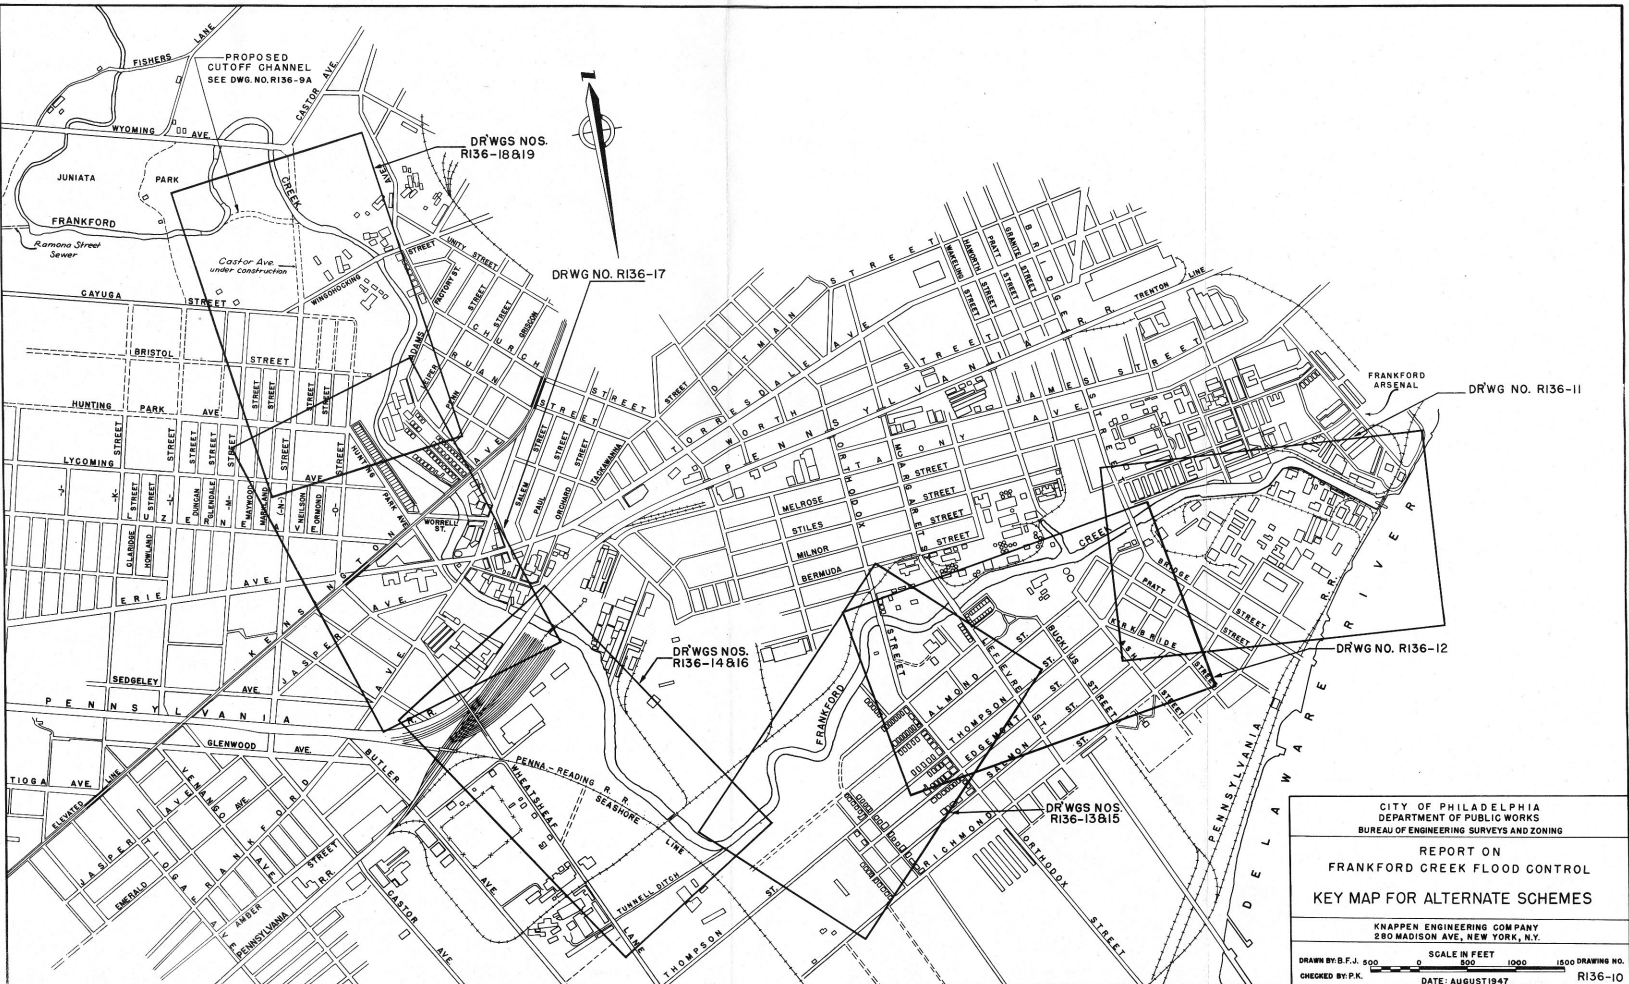
SCALE IN FEET
 0 500 1000 1500 DRAWING NO.
 DRAWN BY B.F.J. 500
 CHECKED BY P.K. DATE: AUGUST 1947 R136-10

REPORT ON
 FRANKFORD CREEK FLOOD CONTROL
 KEY MAP FOR ALTERNATE SCHEMES

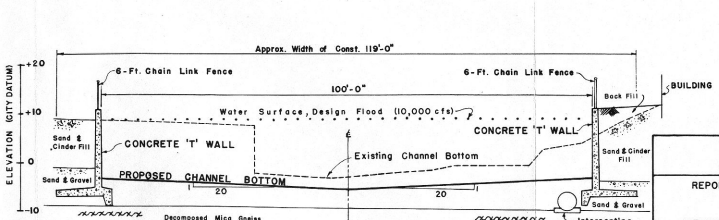
SECTION 16-16
Scale in Feet

NOTE:
SECTION 17-17 (See Dwg. No. R136-B for location) is the same as SECTION 16-16 except that the water surface and top of walls are 1'-6" lower, and the channel bottom would be paved with concrete

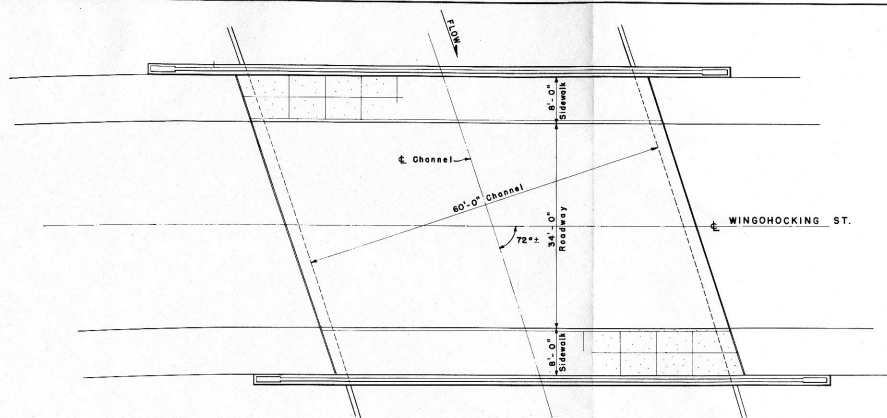
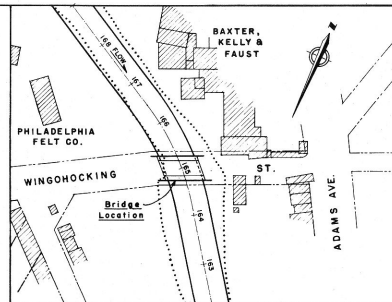
REPORT ON FRANKFORD CREEK FLOOD CONTROL
PLAN, ELEVATION AND SECTION
 PROPOSED BRIDGE AT
 WINGHOCKING STREET
